DURABILITY TESTING RESULTS

*Oak Ridge National Laboratory Report – “Durability Testing of a
Drop-In Heat Pump Water Heater”*

TECHNICAL REPORT

April 2004
500-04-018-A3

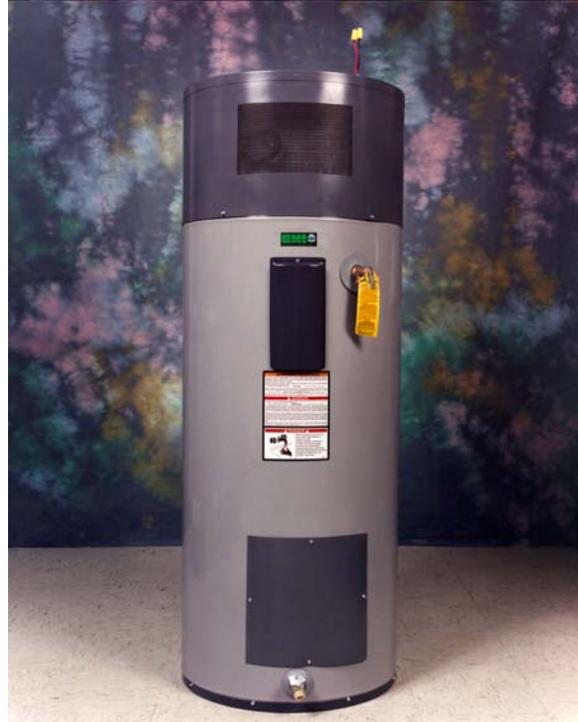
Fig. 1.1. Photograph of the prototype “drop-in” heat pump water heater unit that was the subject of the durability testing discussed in this report.

The HPWH examined in this study was intended to be a “drop-in” replacement for a conventional EWH. It is pictured in Fig. 1.1 and shown in a schematic cut-away view in Fig. 1.2. As used in this report, “drop-in” means that the HPWH can be installed virtually anywhere an EWH can be installed, using essentially the same installation procedures. It is likely that most HPWH installations will require slightly more time than EWH installations because of the requirement to provide for drainage of condensate from the HPWH evaporator.

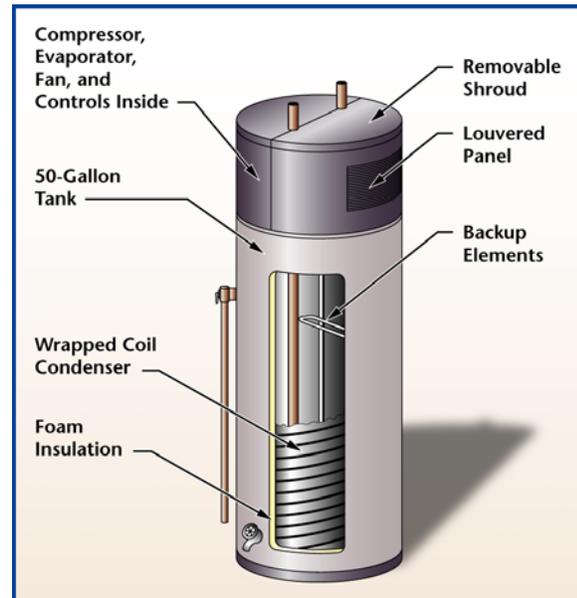
Fig. 1.2. Cutaway schematic view of the HPWH.

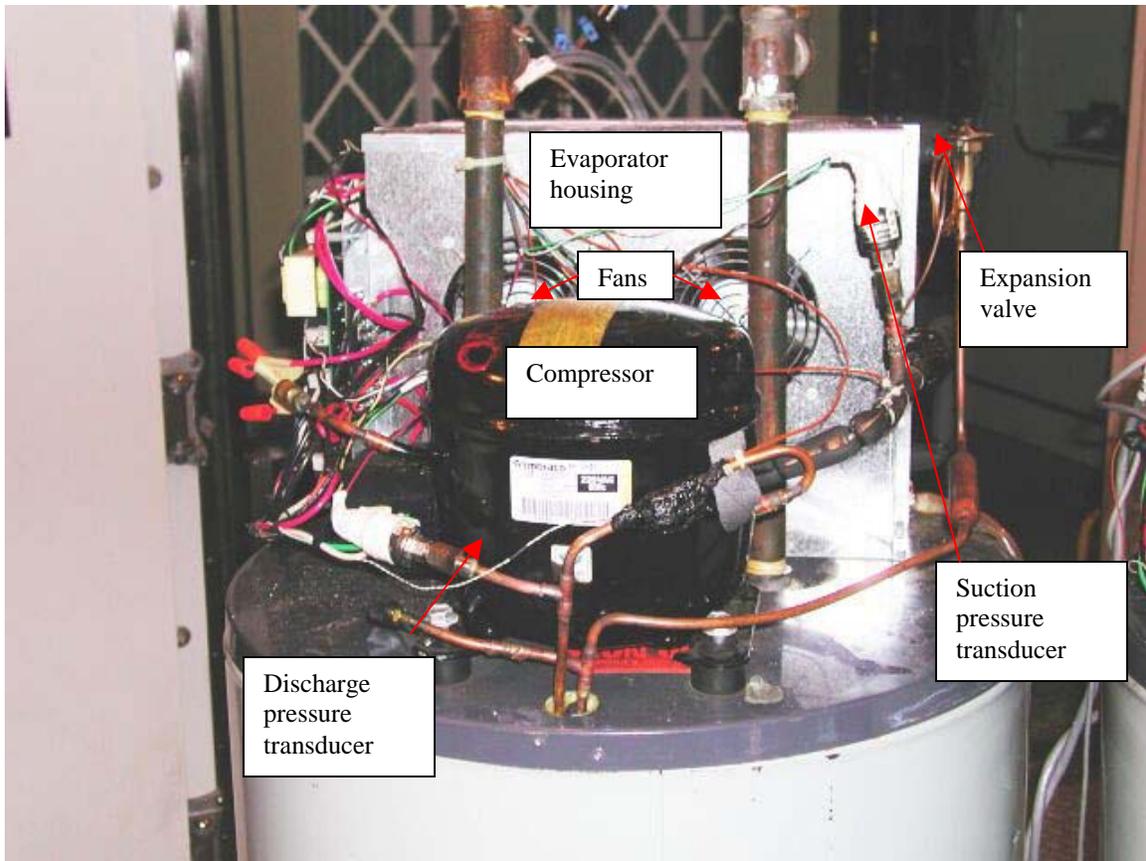
Fig. 1.3. Photo of heat pump section of HPWH showing compressor (foreground), rear of evaporator housing (background), and thermal expansion valve (right-hand side).

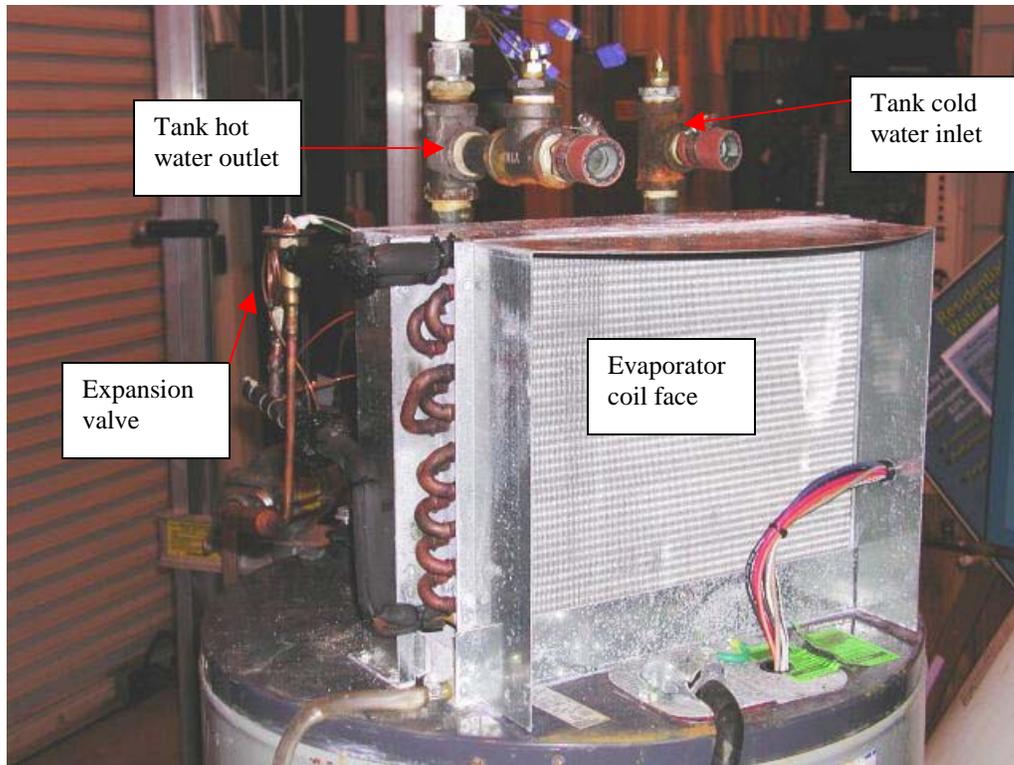
Fig. 1.4. Photo of heat pump section of the HPWH showing front of evaporator with thermal expansion valve to the left.

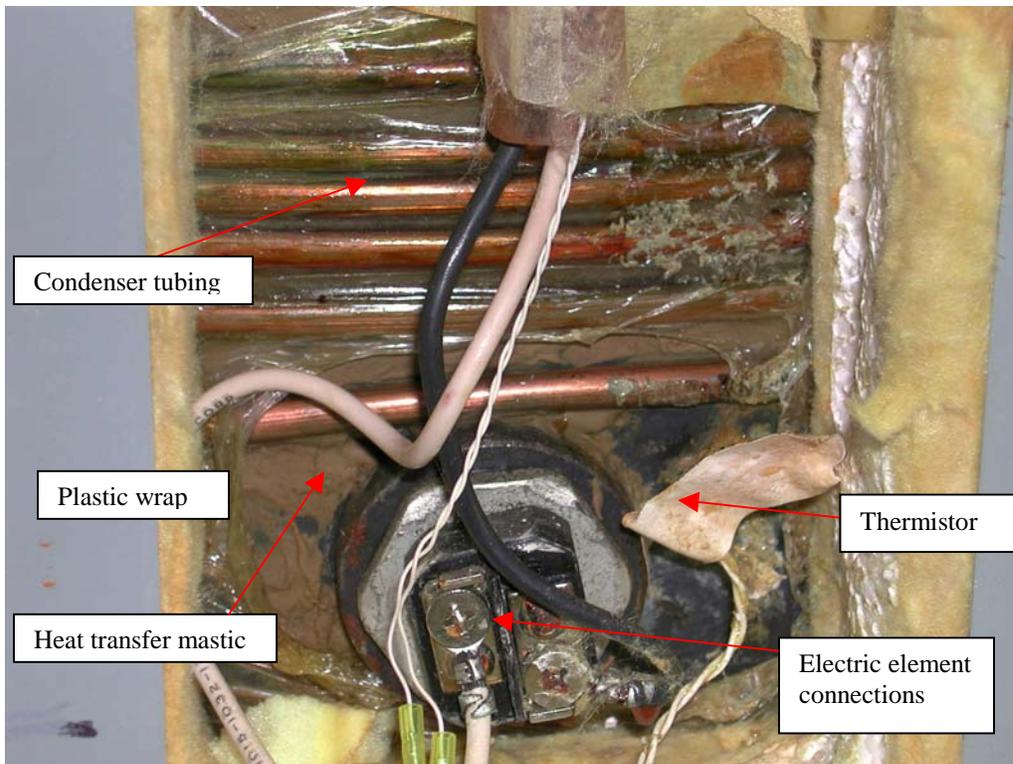
Fig. 1.5. Photo of section of HPWH condenser near bottom of tank in vicinity of lower electric element.

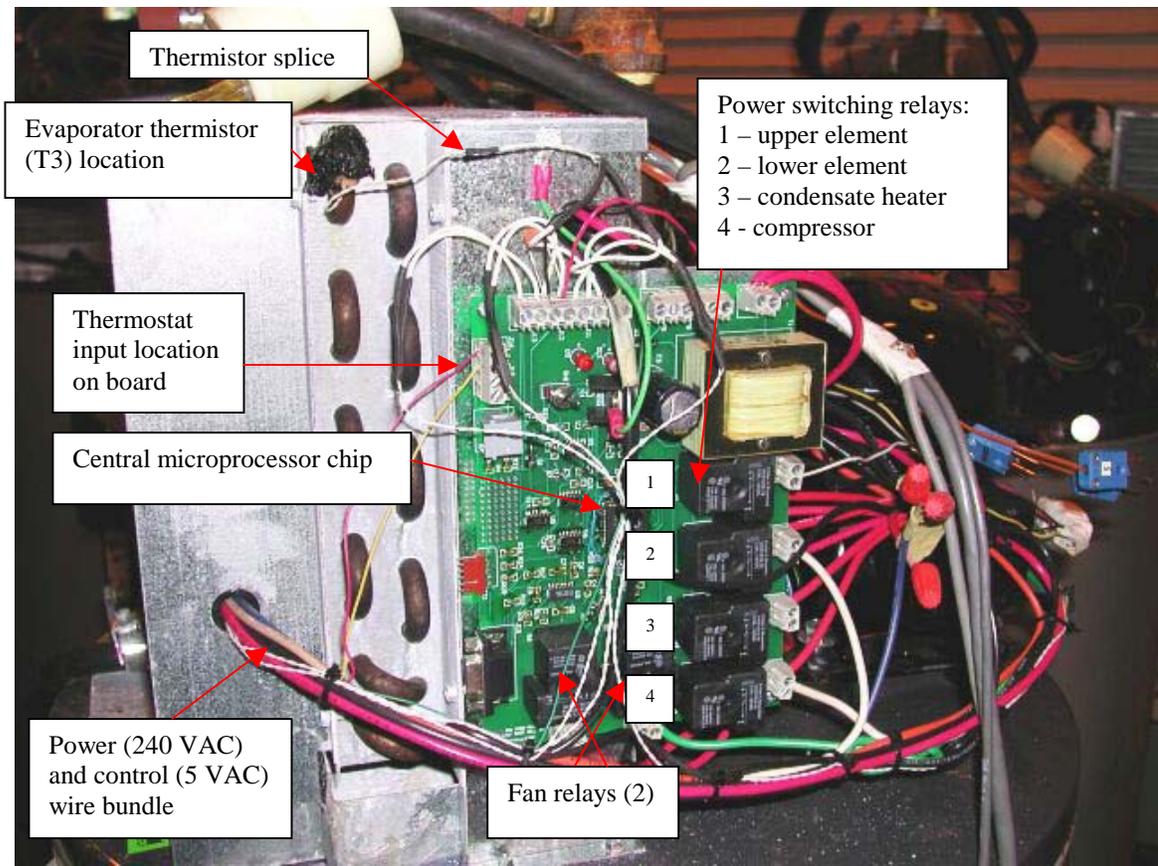
Fig. 1.6. Photo of first-generation HPWH solid-state control board. The microprocessor is in the middle, partially obscured by the wire bundle.

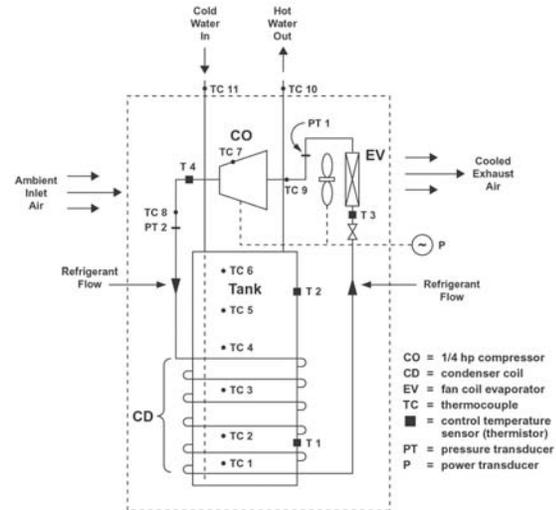
Fig. 2.1. Schematic of heat pump water heater test setup showing data instrumentation locations and control thermistor (T1–T4) locations.

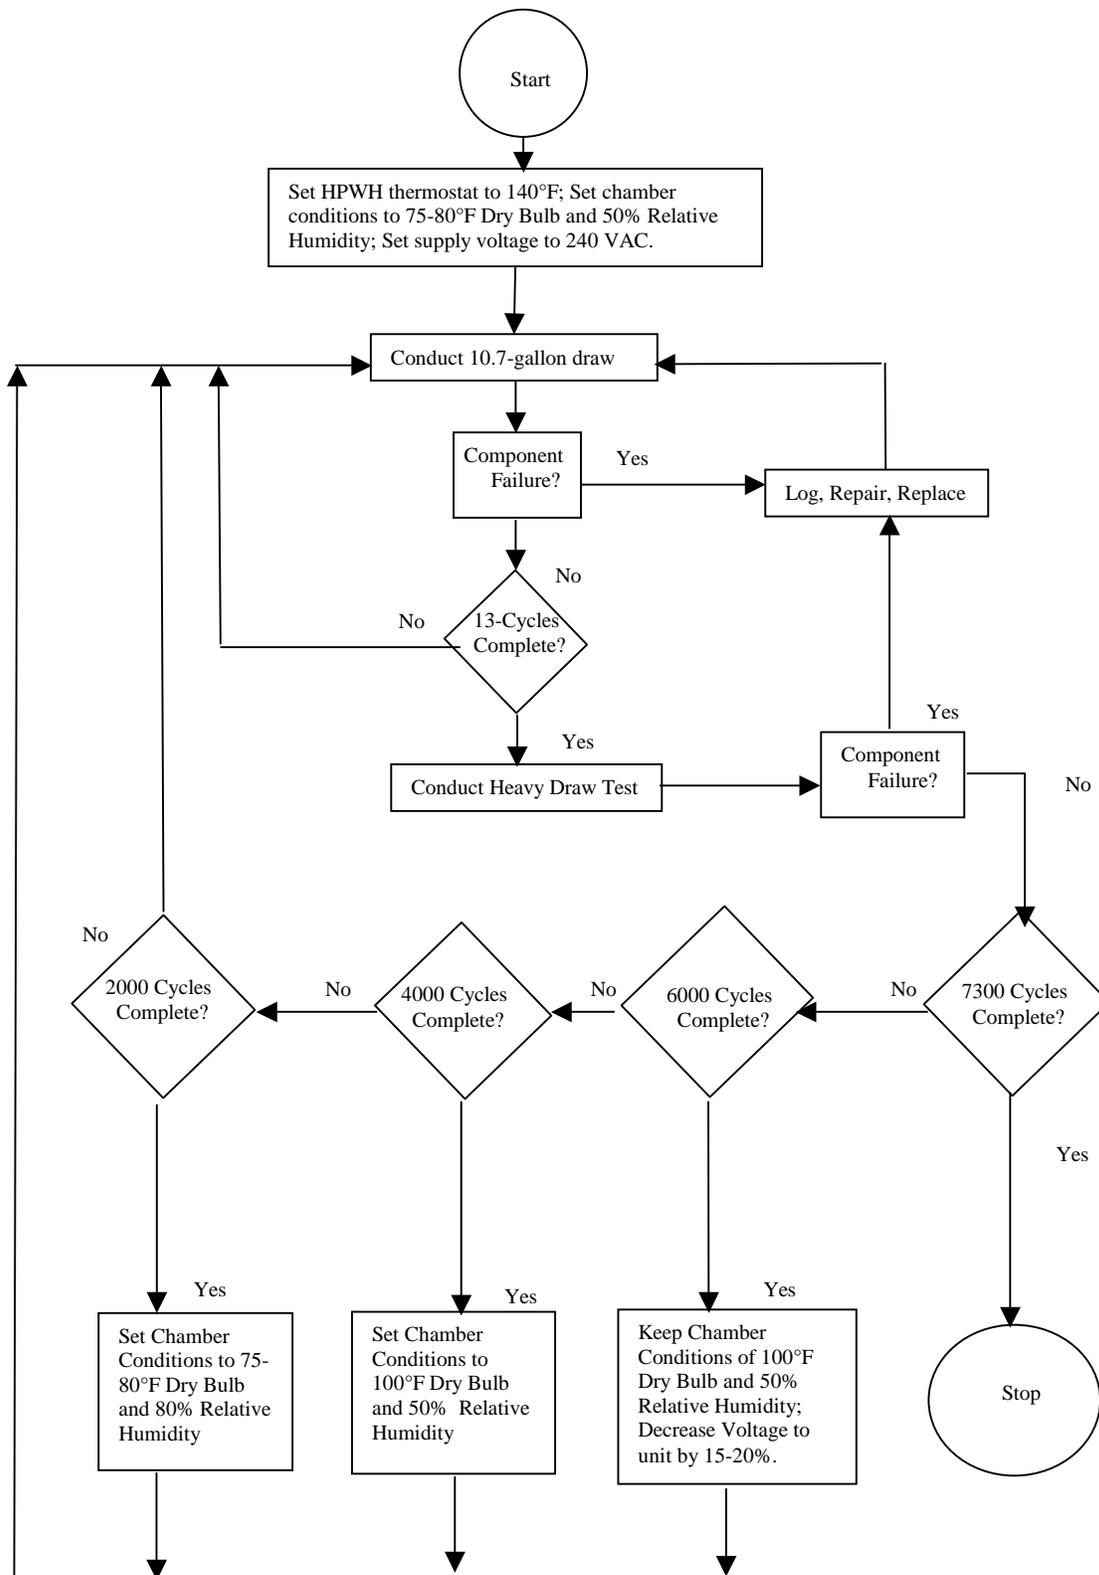
Fig. 2.2. HPWH durability test protocol.

At the conclusion of the durability tests, ambient and power supply conditions were shifted to stage 5 levels and the EF of each unit was measured according to the DOE Simulated Use Test. Supplemental hot water feedback flow was disabled for these EF tests. Subsequently the compressors were removed and checked for wear in cooperation with the compressor manufacturer. The tanks were returned to the HPWH manufacturer for examination of the condenser/tank adhesion quality and insulation condition and a visual check of other components. A flowchart of the durability testing protocol is shown in Fig. 2.2.

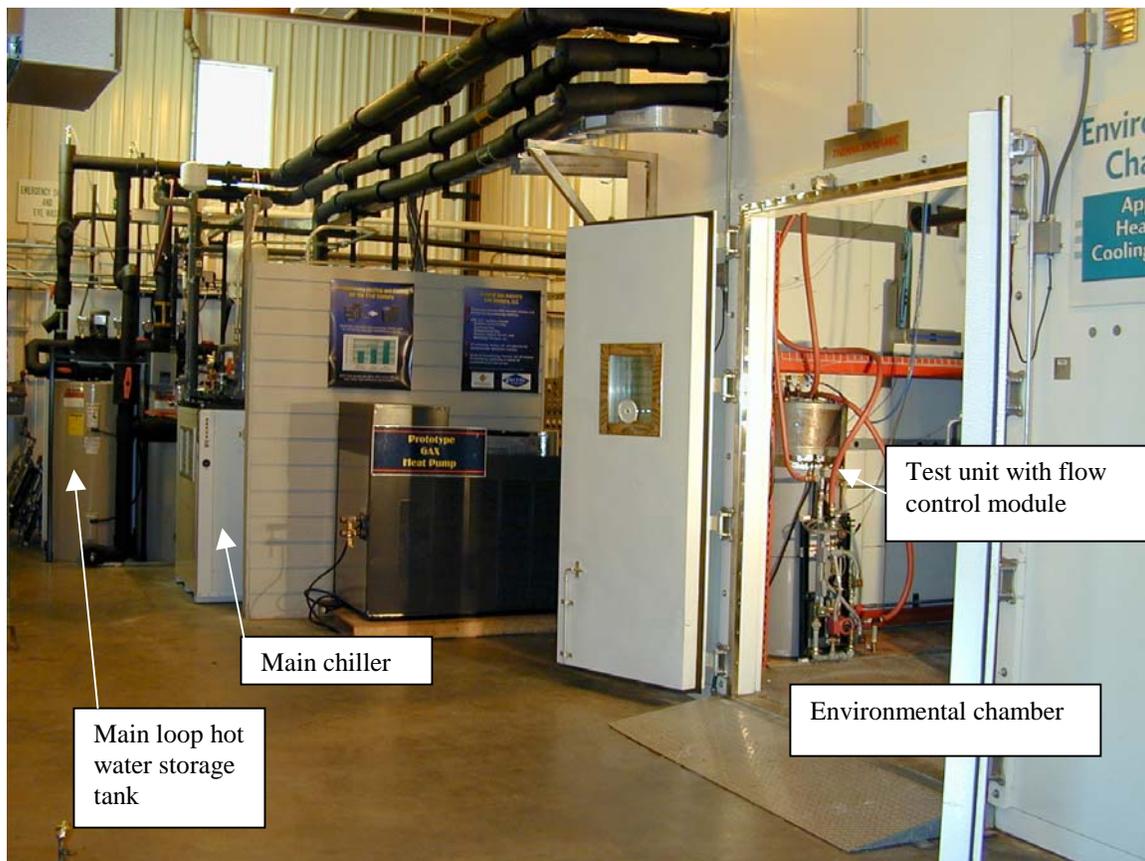
Fig. 3.1. Overall view of heat pump water heater durability test facility.

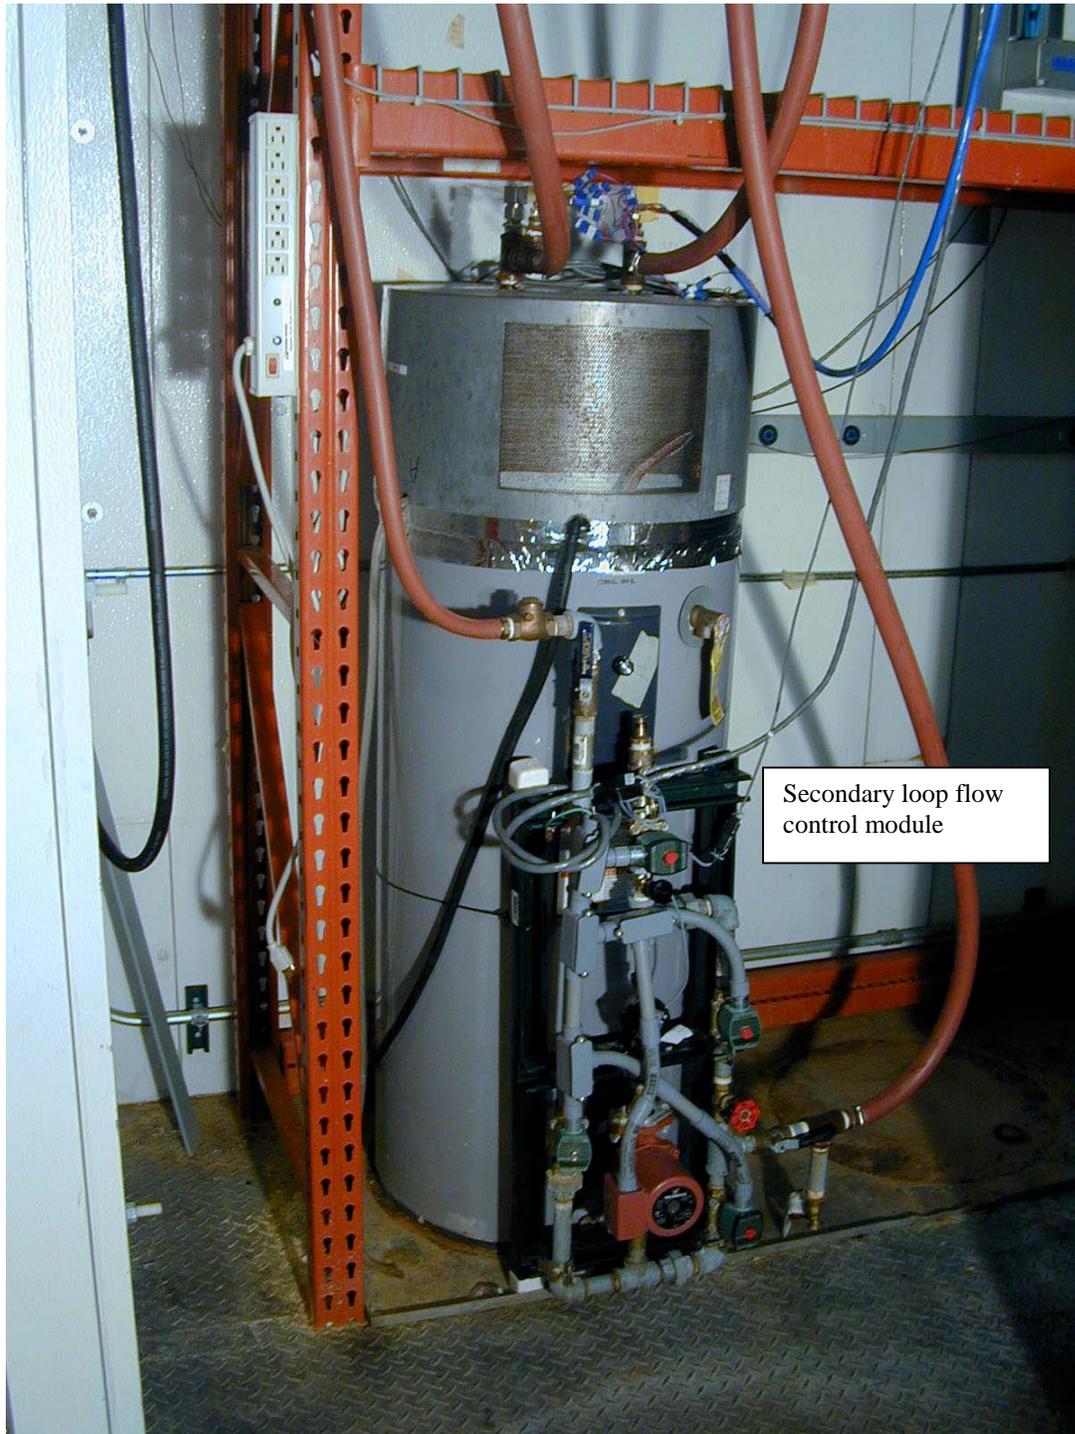
Fig. 3.2. Sample installation of test heat pump water heater inside environmental test chamber. Five heat pump water heaters were placed on the chamber floor like the unit shown. Five more were placed on the shelf above the floor units.

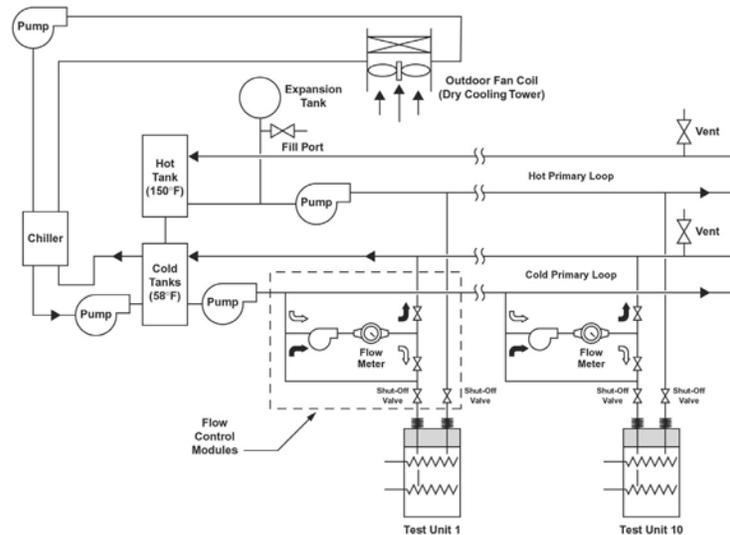
Fig. 3.3. Schematic of HPWH test facility plumbing connections.

Figure 3.3 shows a schematic of the test stand used for the durability tests. A primary/secondary loop approach was used for providing cold and hot water to each test unit according to its individual demand. For clarity, Fig. 3.3 shows only two HPWH units each with secondary piping. However, the two primary loops (hot and cold) were connected to each of the ten secondary loops.

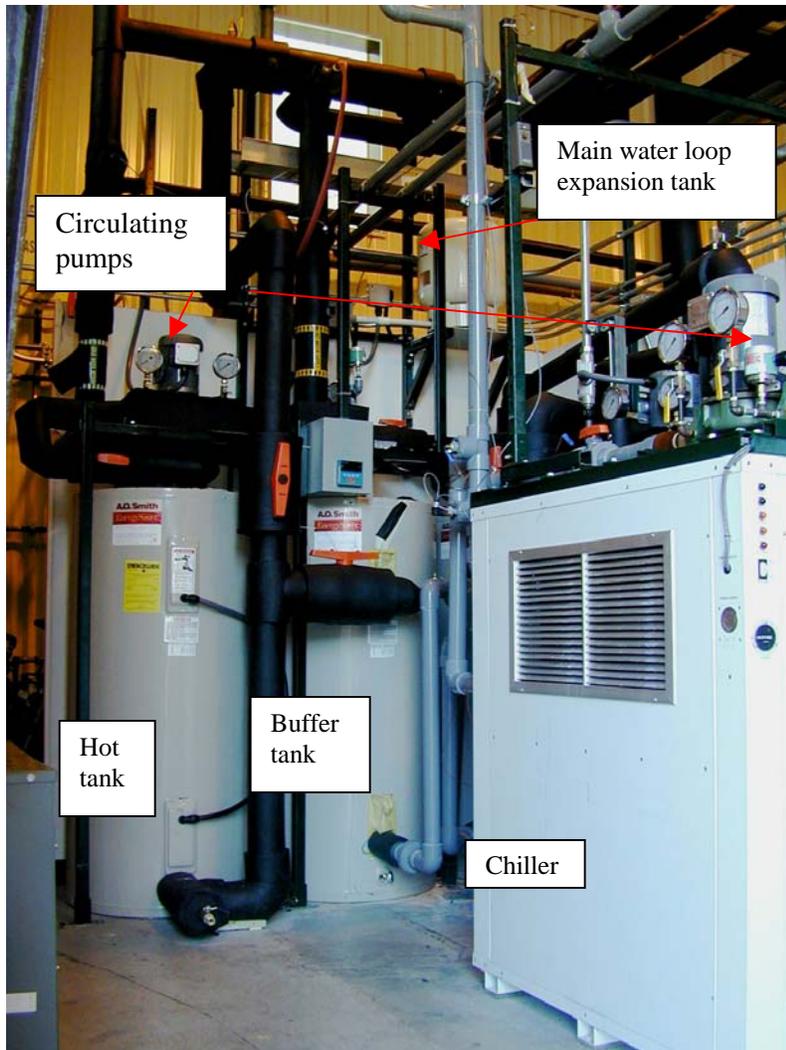
Fig. 3.4. Photo of heat pump water heater test facility chiller and primary water storage tank section.

The hot tank with electrical connections to the two heating element access covers can be seen at the left-hand side of the photo in Fig. 3.4. Just to its right is the buffer tank, and the chiller unit is pictured in the foreground. The two cold water tanks are located between the chiller and the buffer tank but are obscured in the photo by the chiller. All of the system components, except the outdoor fan coil, are located within the Buildings Technology Center’s laboratory facilities in Building 3144A at ORNL. Standard, residential 120-gal electric water heater tanks were used for primary system hot, cold, and buffer water storage. Two 5500-W electric heating elements in the hot tank were used to keep the hot loop at operating temperature conditions (150°F). The controls supplied with this water heater were modified so that both heating elements could be operated simultaneously. The buffer tank was used to provide for flow and pressure balancing between the two primary loops when water

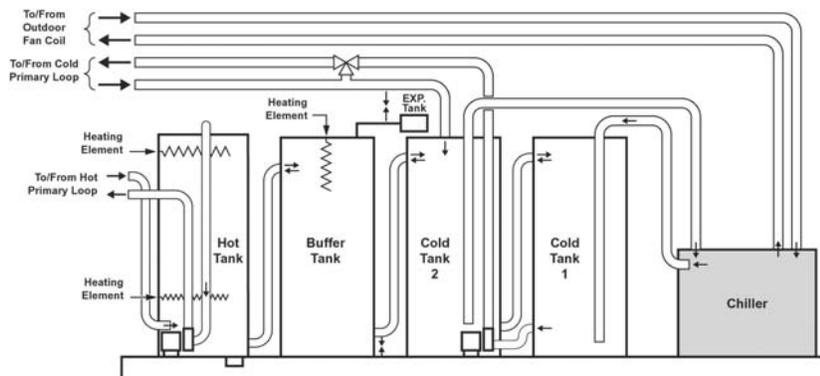
Fig. 3.5. Schematic of heat pump water heater test facility chiller and primary water storage tank section.

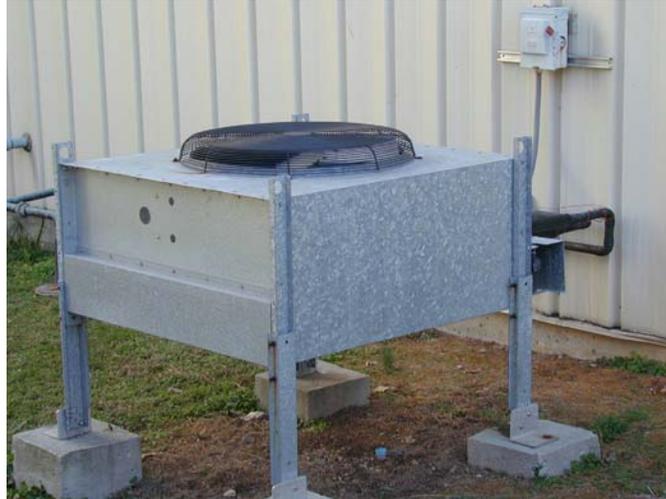
Fig. 3.6. Photo of outdoor fan coil used for chiller heat rejection.

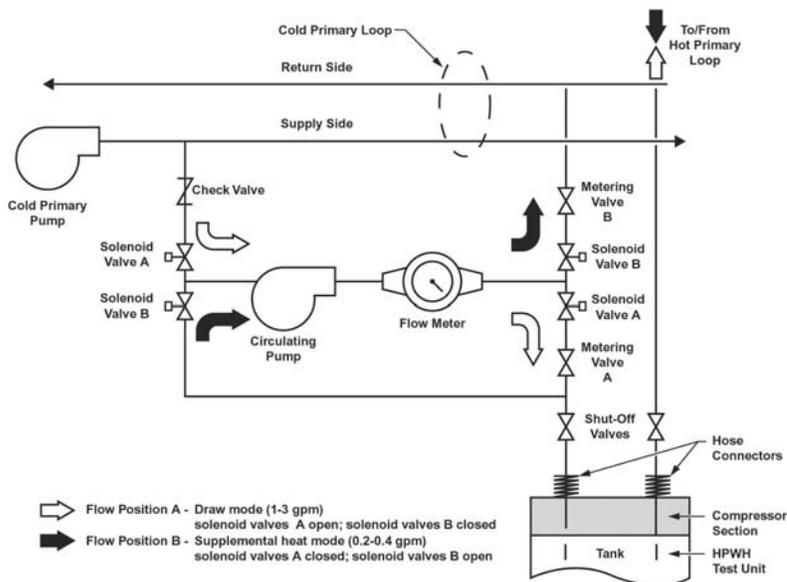
Fig. 3.7. Schematic of secondary loop flow control module.

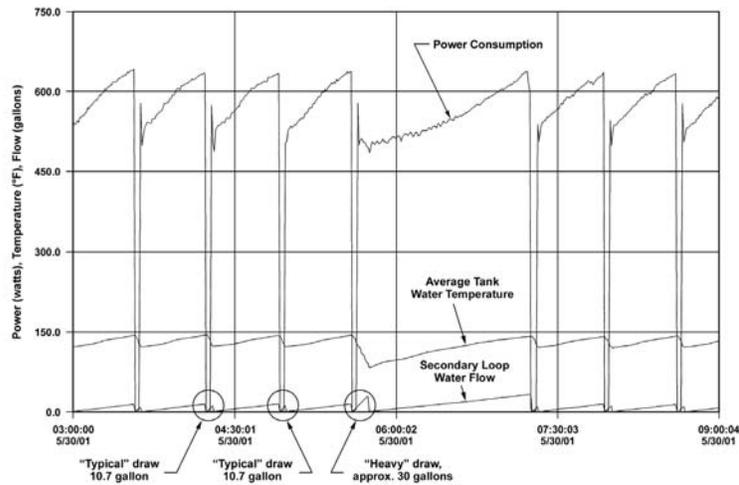
Fig. 4.1. Representative cycling behavior of test heat pump water heater 1 over a 6-h period. Power consumption, average tank water temperature, and secondary loop total flow vs. time shown. Cycling rate was approximately 32 cycles/day at this point in time.

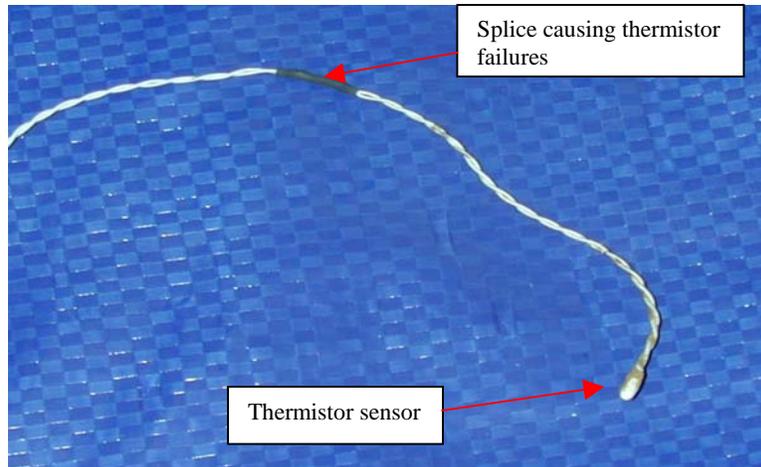
Fig. 4.2. Close-up photo of thermistor used as temperature sensor in first-generation control design.

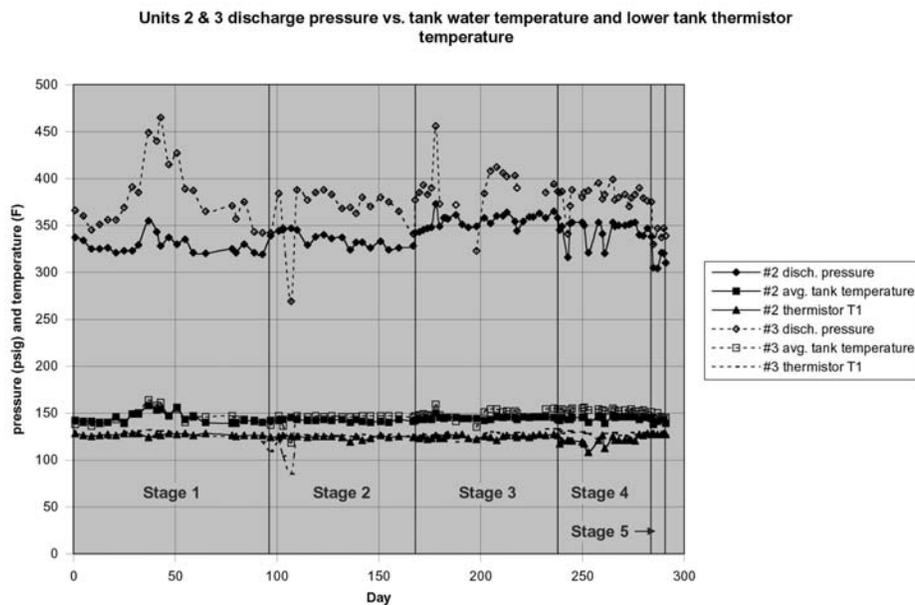
Fig. 4.3. Representative end-of-cycle discharge pressure, average tank water temperature, and lower tank (T1) thermistor readings for units 2 and 3 throughout the durability run.

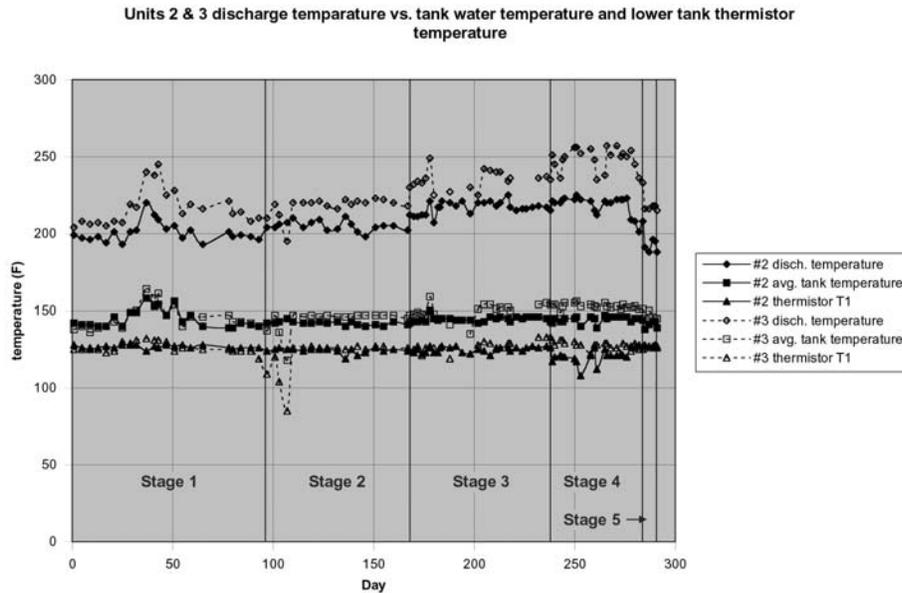
Fig. 4.4. Representative end-of-cycle discharge temperature, average tank water temperature, and lower tank (T1) thermistor readings for units 2 and 3 throughout the durability run.

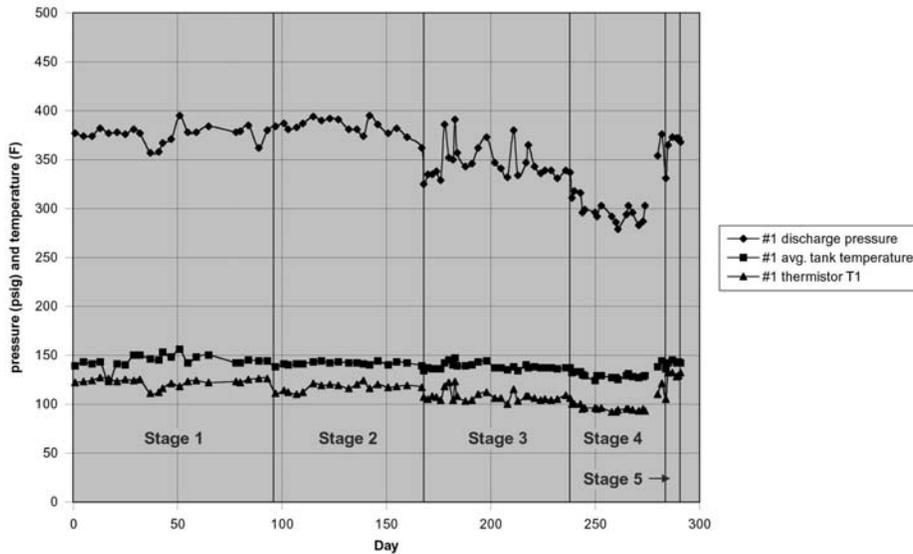
Unit 1 discharge pressure vs. tank water temperature and lower tank thermistor temperature

Fig. 4.5. Representative end-of-cycle discharge temperature, average tank water temperature, and lower tank (T1) thermistor readings for unit 1 throughout the durability run.

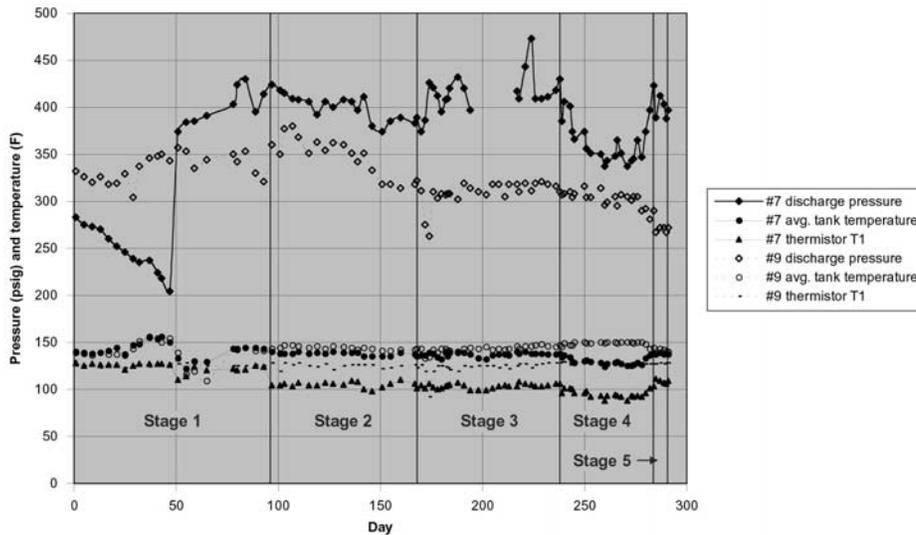
Units 7 & 9 discharge pressure vs. tank water temperature and lower tank thermistor temperature

Fig. 4.6. Representative end-of-cycle discharge pressure, average tank water temperature, and lower tank (T1) thermistor readings for units 7 and 9 throughout the durability run.

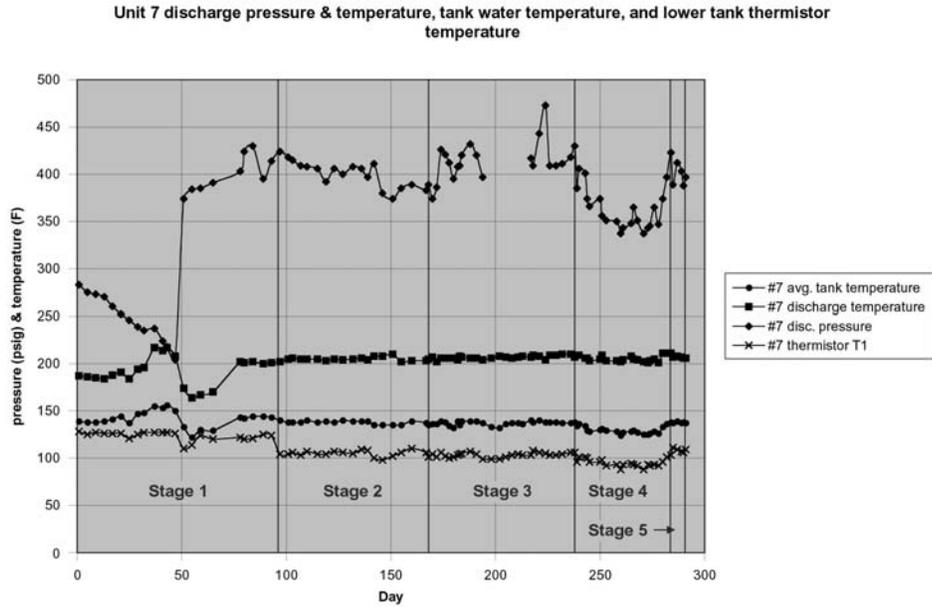
Fig. 4.7. Representative end-of-cycle discharge pressure and temperature, average tank water temperature, and lower tank (T1) thermistor readings for unit 7 throughout the durability run.

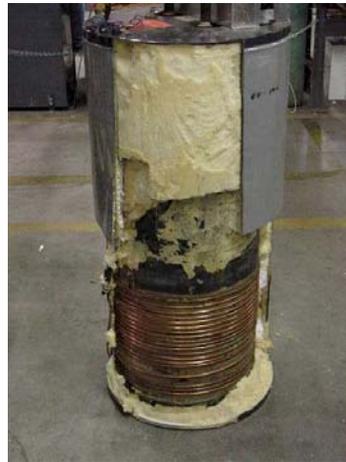
Fig. 4.8. Heat pump water heater tank with insulation stripped away from the lower half to reveal condenser wrap.

The information presented in this section came primarily from John Hoyt (2001) of EMI (the HPWH manufacturer). Nine of the test HPWHs were cut apart as shown in Figs. 4.8, 4.9, and 4.10 to examine the post-test condition of the condenser and tank. A full report is included in Appendix B, and highlights are listed here.

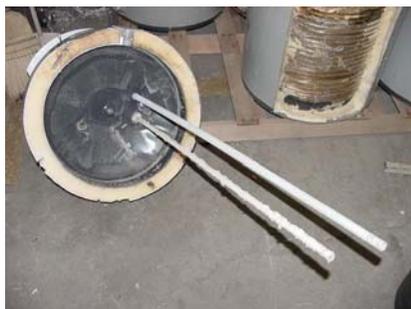
Fig. 4.9. Top end cap of tank with dip tube (cold water inlet) and anode rod exposed.

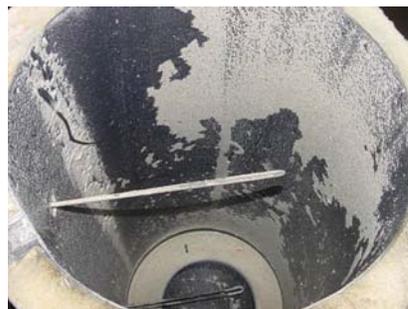
Fig. 4.10. Interior view of heat pump water heater tank.

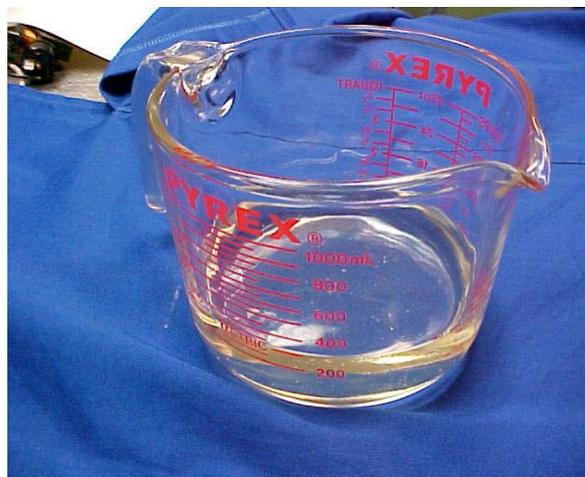
Fig. 4.11. Oil charge removed from compressor 5.

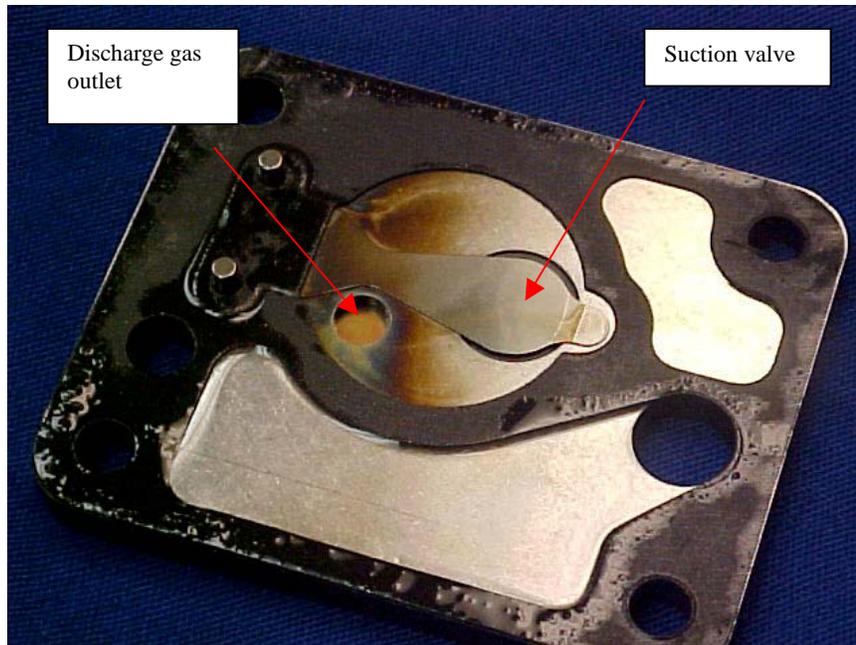
Fig. 4.12. Valve plate from compressor 5—bottom.

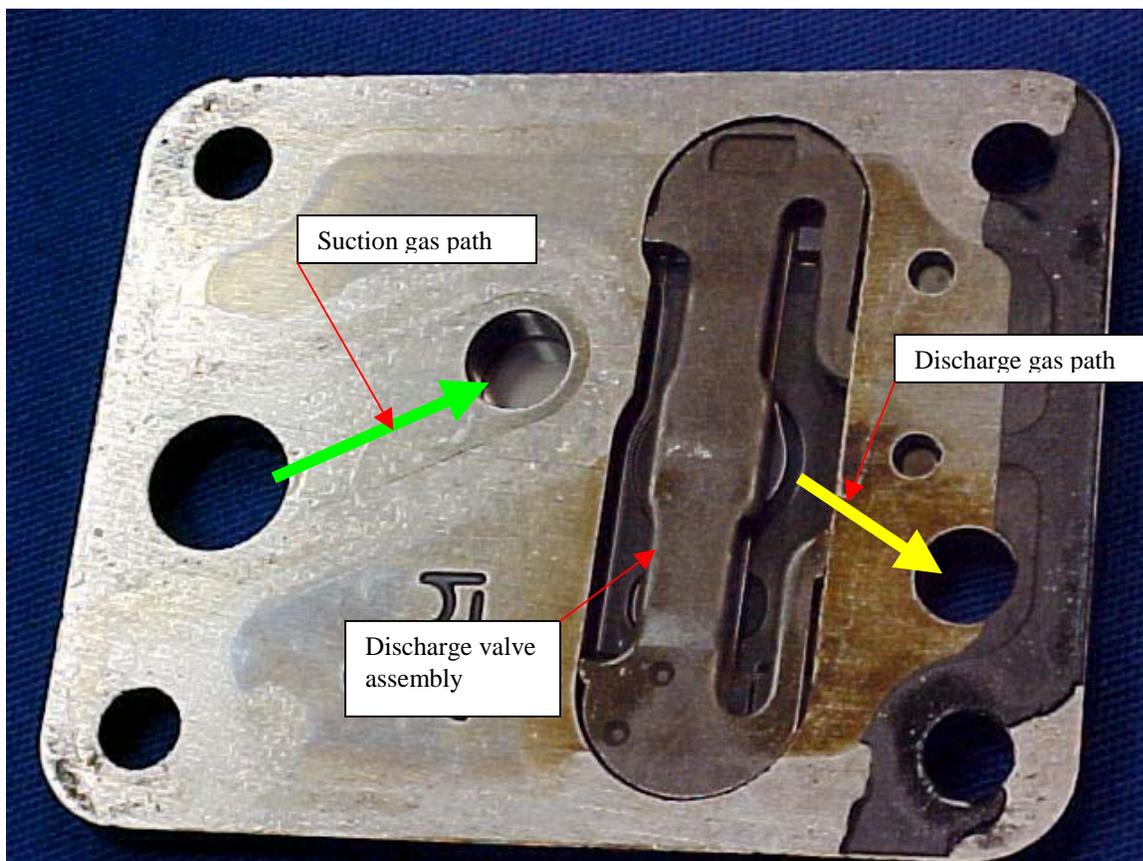
Fig. 4.13. Valve plate from compressor 5—top.

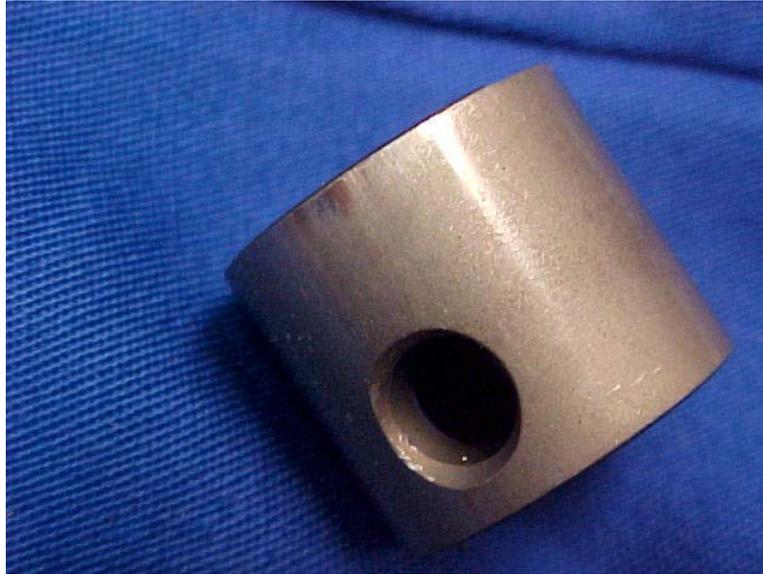
Fig. 4.14. Piston from compressor 5.

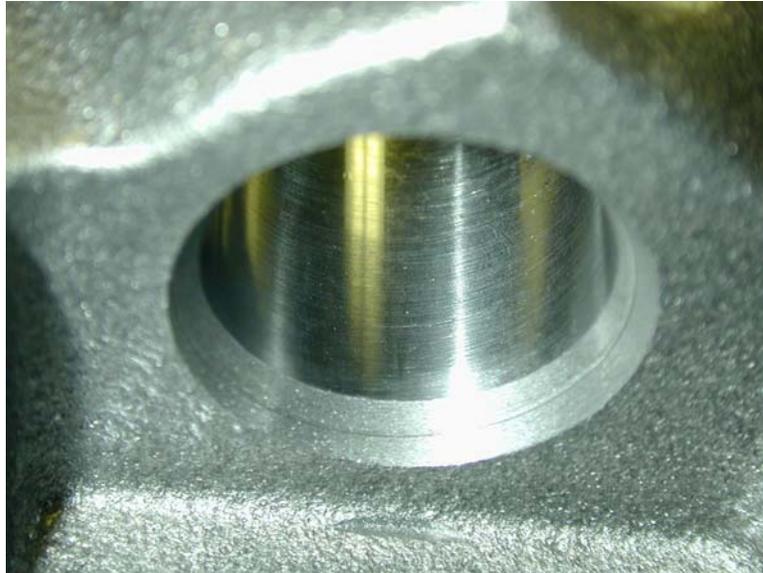
Fig. 4.15. Compressor 5 cylinder wall, view from bottom.

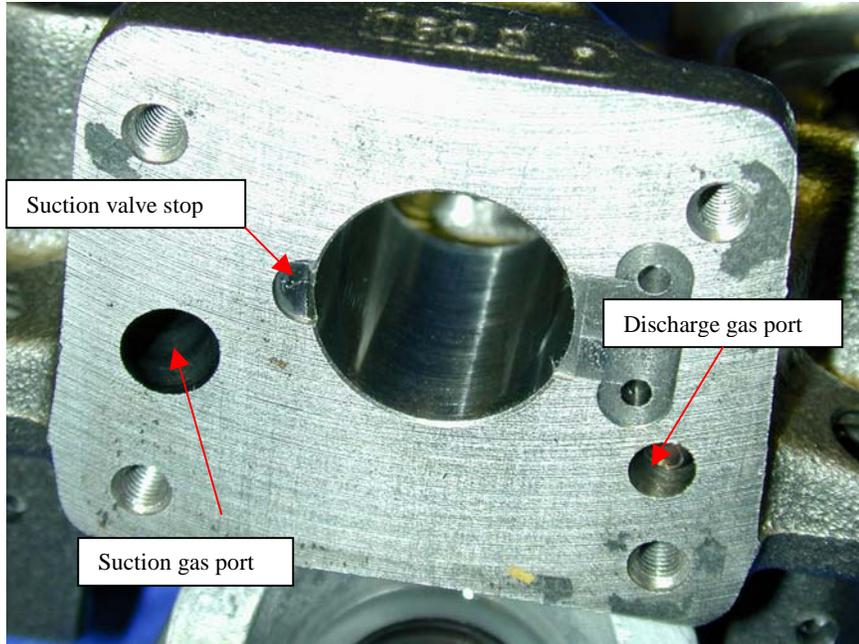
Fig. 4.16. Compressor 5 cylinder wall, view from top of cylinder block; note suction gas port to left of cylinder and discharge gas port to right of cylinder.

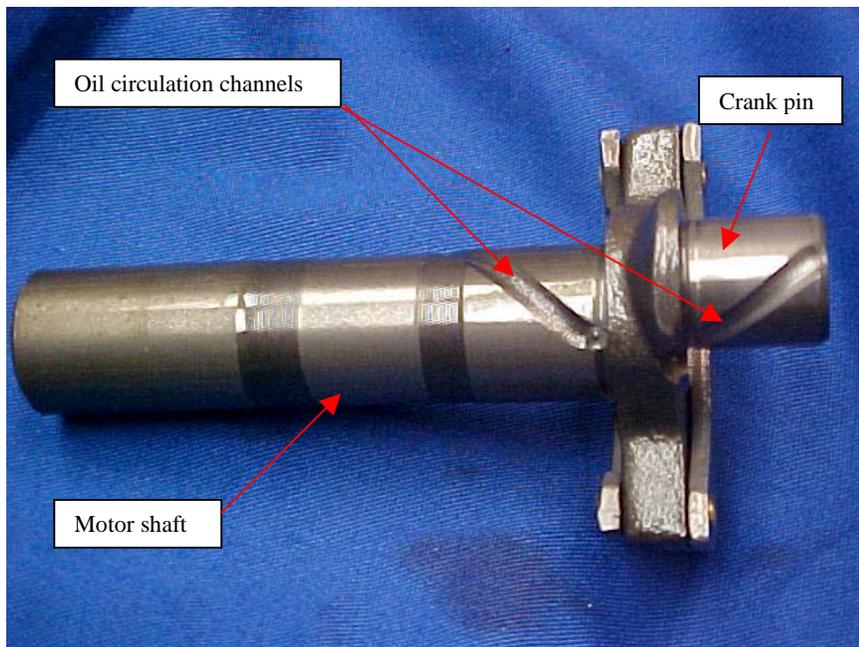
Fig. 4.17. Compressor 5 motor shaft. Piston rod crank pin is on right side of photo; grooves are for oil circulation.

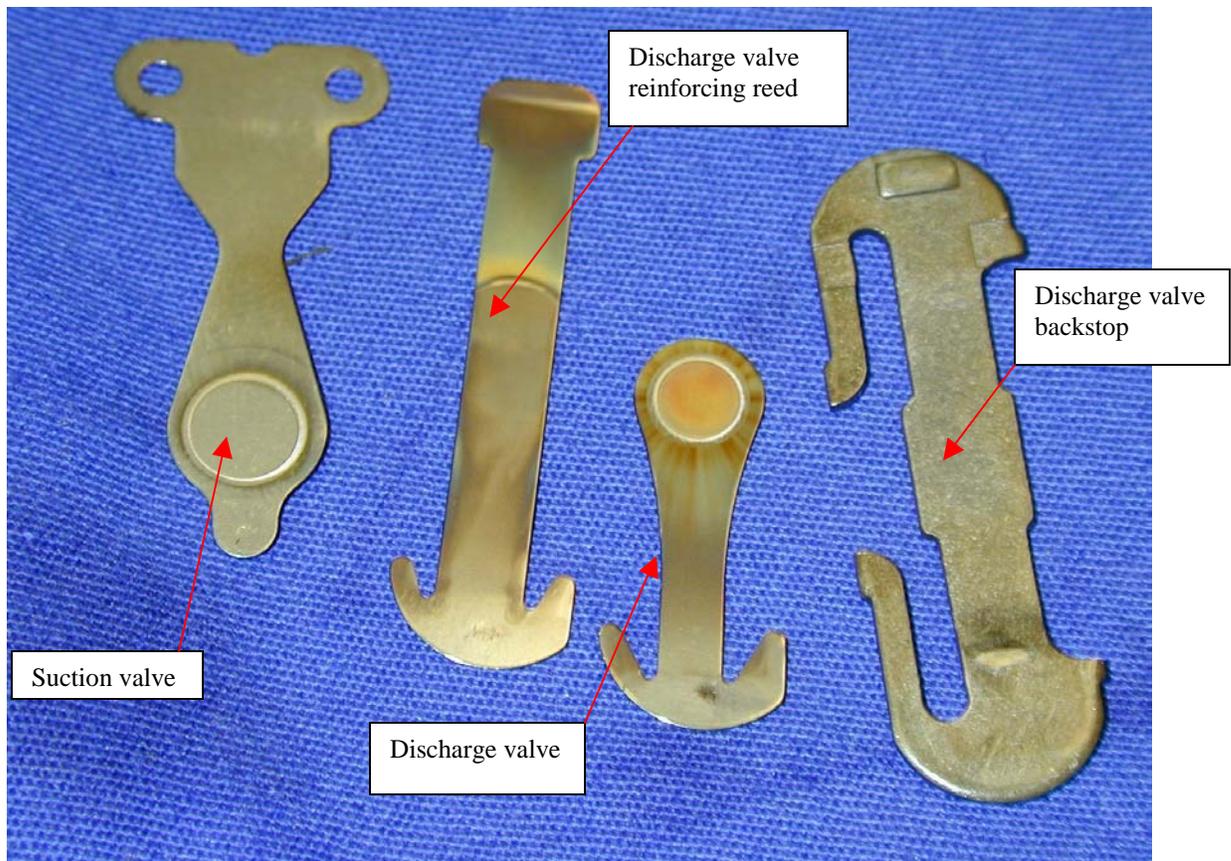
Fig. 4.18. Compressor 5 suction valve (far left) and discharge valve assembly (three pieces, left to right: reinforcing reed, valve, backstop).

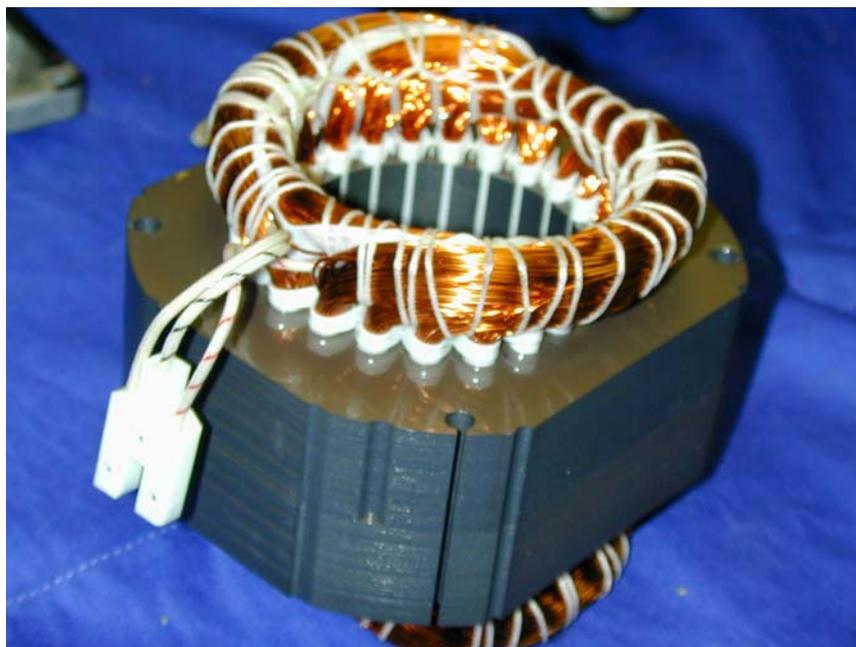
The motor and windings were clean, with no evidence of insulation degradation or scorching (Fig. 4.19). The contact points from the start relay (Fig. 4.20) and over-temperature protection relay (Fig. 4.21) showed some carbon buildup, as might be expected after 7300+ starts, but still functioned adequately (the motor was started up a few times before disassembly).

Fig. 4.19. Compressor 5 motor windings.

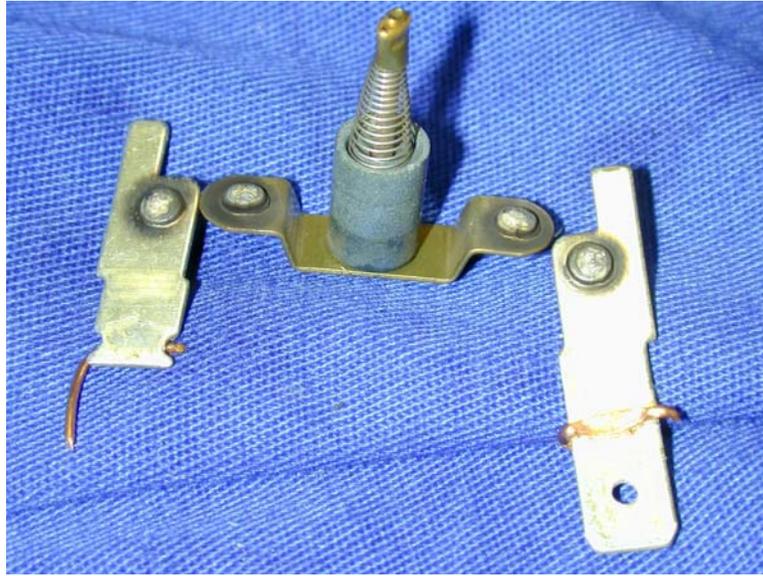
Fig. 4.20. Compressor 5 start relay points.
