DURABILITY TESTING RESULTS

*Oak Ridge National Laboratory Report – “Durability Testing of a
Drop-In Heat Pump Water Heater”*

TECHNICAL REPORT

April 2004
500-04-018-A3

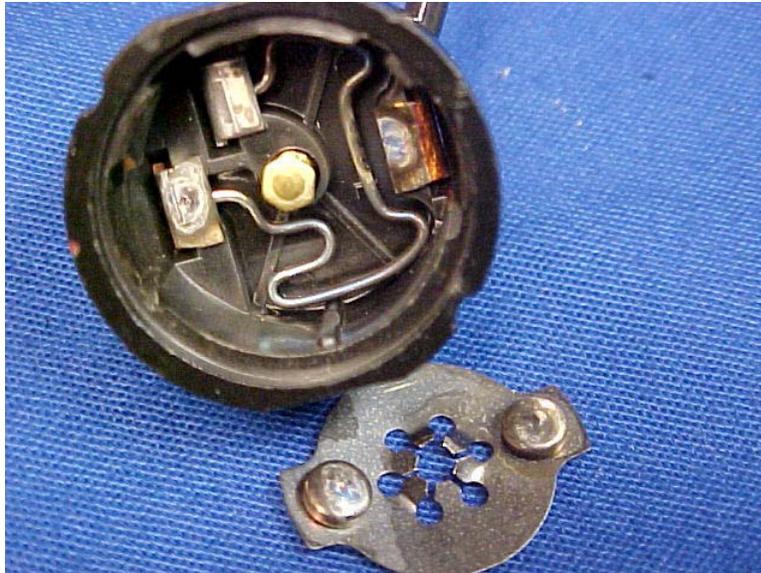
Fig. 4.21. Compressor 5 over-temperature cutout relay.

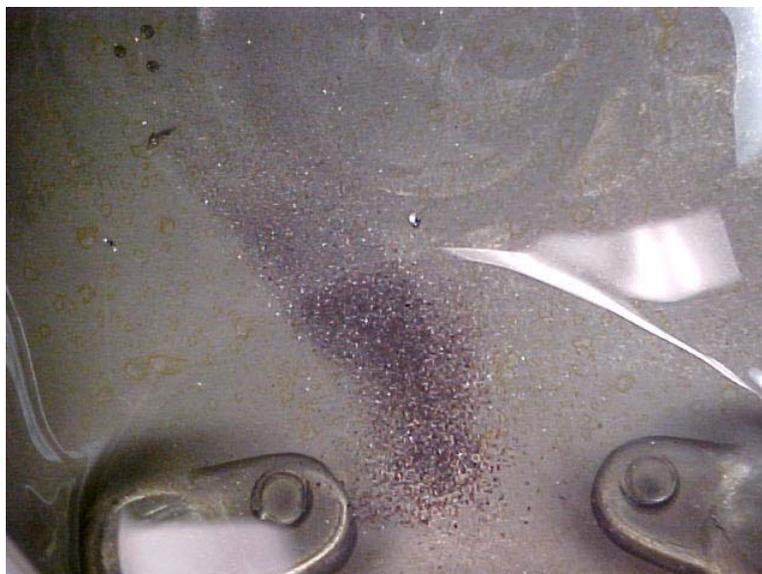
The most worrisome observation was that there were small (iron and copper) particles in the oil at the bottom of the compressor can (Fig. 4.22). These were also found in the compressors examined at Embraco's Brazil facilities. As noted earlier, there was no evidence of scoring on the piston, cylinder wall, or bearing surfaces of Compressor 5 as might be expected if these particles were being circulated. They probably stayed at the bottom of the can during the test period or were lodged on the can wall during operation and migrated to the sump because of vibration during shipping to Embraco. Embraco personnel did not think it likely that these particles accumulated during the production process. The HPWH systems were opened up several times to add, repair, or replace the pressure transducers and other test fittings. It is probably more likely that these particles were introduced into the system during those operations.

Fig. 4.22. Debris particles found in bottom of oil sump on compressor 5.

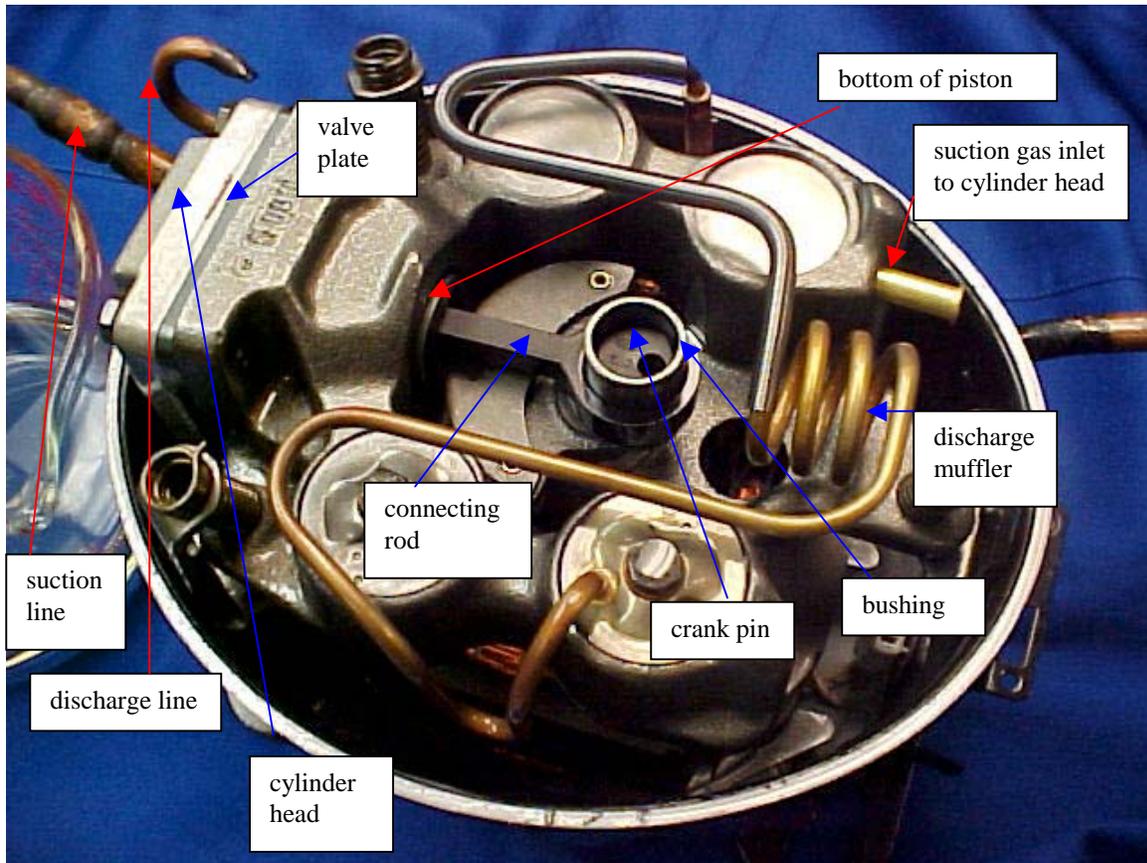
Fig. 4.23. Compressor 5 view showing top end of compressor assembly with crank pin, bushing, and piston connecting rod clearly visible.

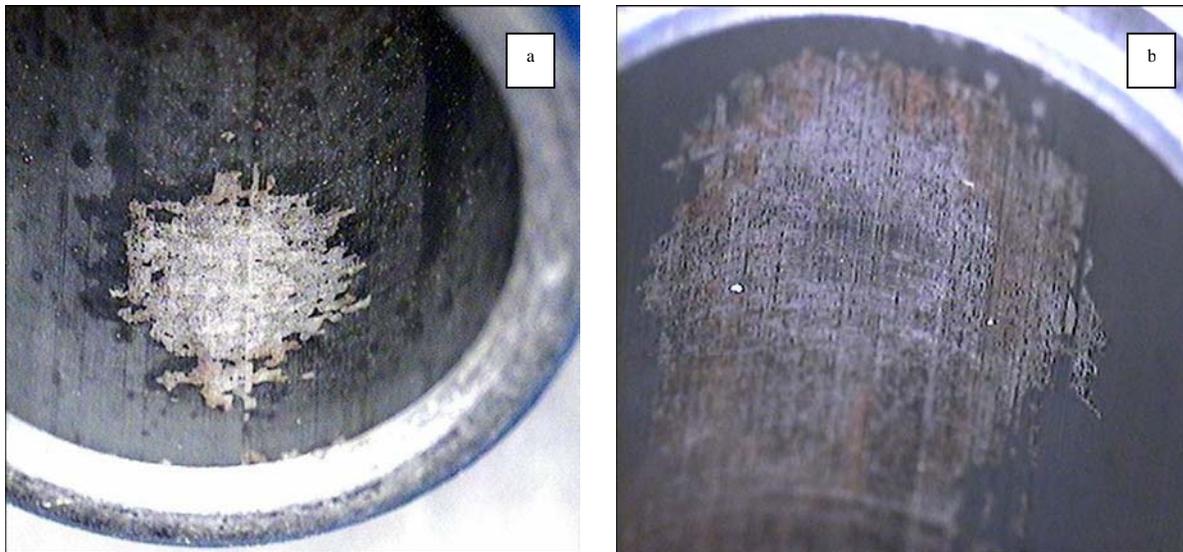
Fig. 4.24. Compressor bushings 2(a) and 8(b) showing severe (2) and moderate (8) polishing with detachment of the steam-treated layer (Fe_3O_4). This detachment was verified at least in a low intensity in all of the bushings, but it reached the moderate level in compressors 3 and 8 and severe level in compressor 2.

and bushing 8(b), respectively, illustrating the wear pattern. The bushing from compressor 5 (Fig. 4.25) exhibited a similar wear pattern but to a much less severe degree than the bushings from either unit 2 or 8. Both the bushing and the crankpin (and presumably many of the other load-bearing components) are given a steam treatment or hardening during manufacturing, which puts a layer of Fe_3O_4 on the material surface. In the case of bushing 2, this hardened layer has been completely worn away, hence the “severe” wear rating. The “moderate” wear rating for the #2, #3, and #10 crankpins and the #3 and #8 bushings indicated that, on these components, this layer had some significant polishing but was not worn through.

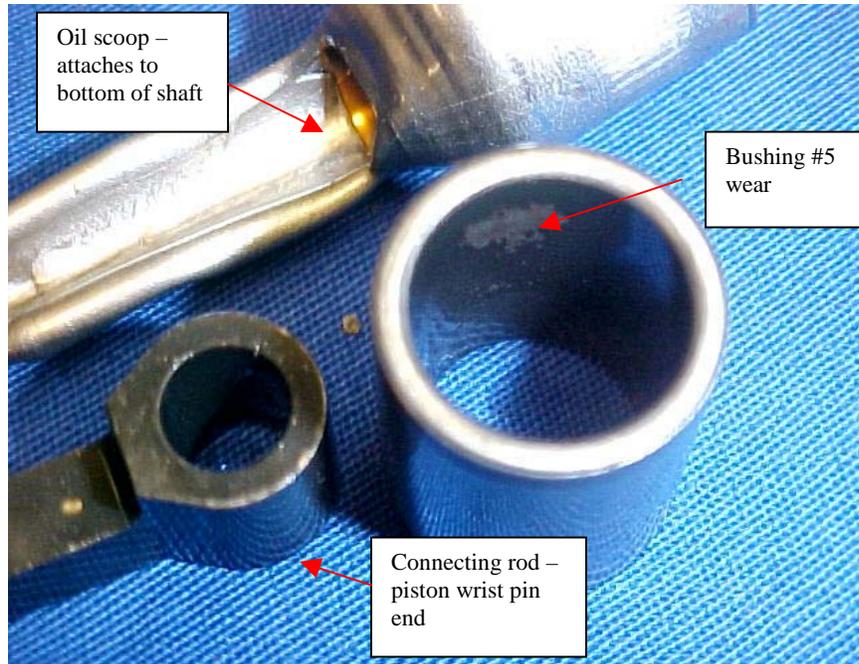
Fig. 4.25. Bushing from compressor 5 showing polishing wear on inside surface (area in contact with crank pin).

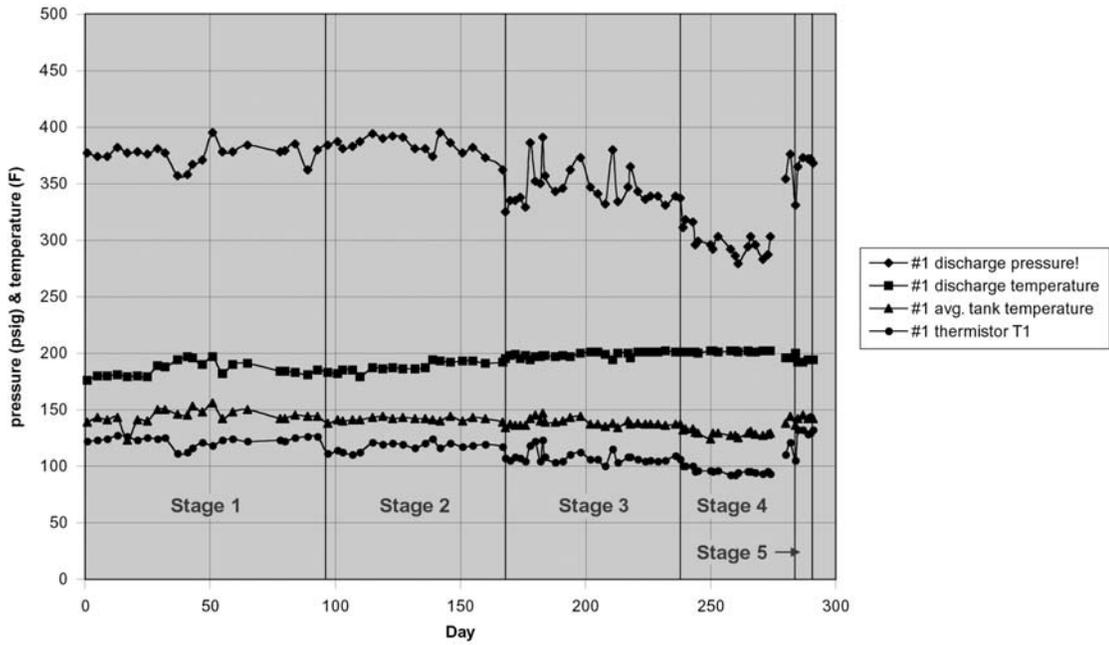
Figure A2. Unit 2 end-of-cycle discharge pressure & temperature, tank temperature, and lower tank thermistor temperature

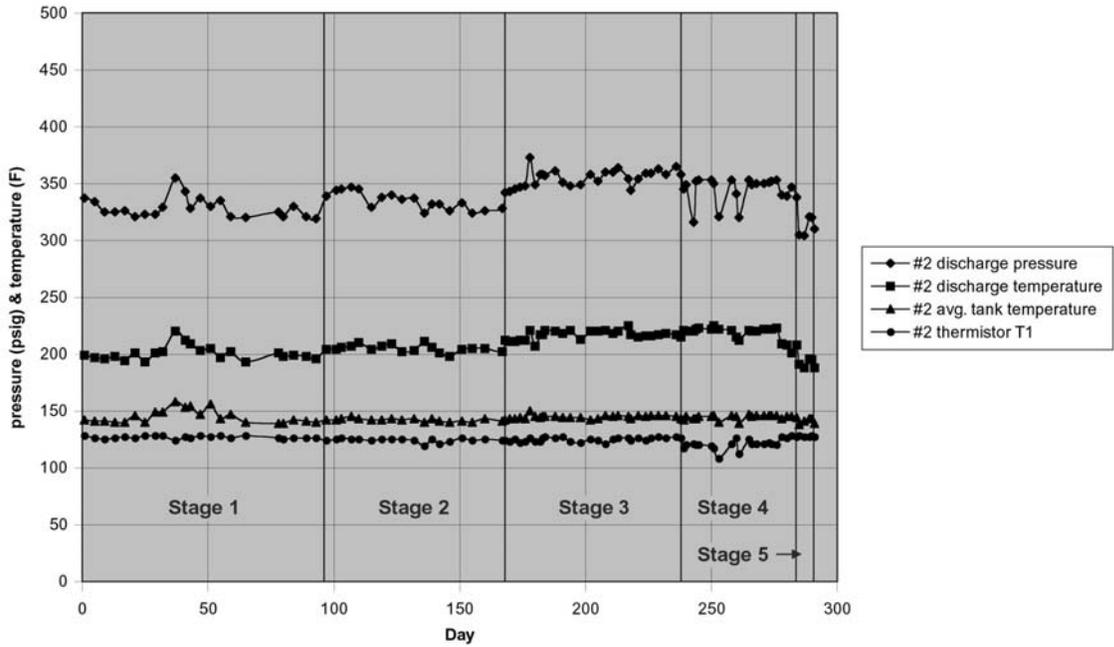
Figure A3. Unit 3 end-of-cycle discharge pressure & temperature, tank temperature, and lower tank thermistor temperature

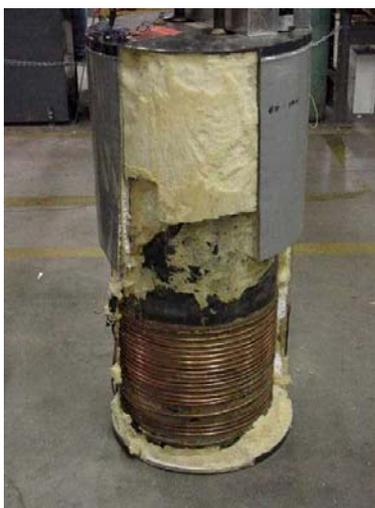
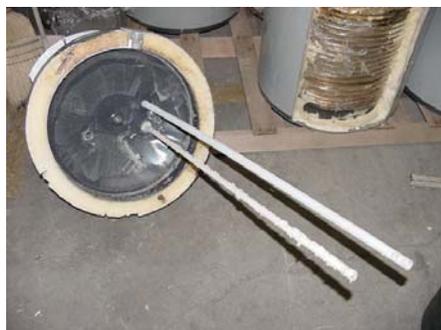
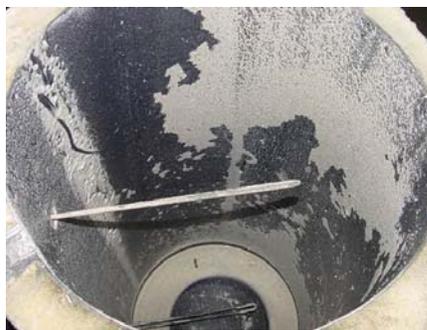
EMI received tanks numbered 1, 2, 3, 4, 5, 7, 8, 9, 10 (Tank #6 remained at ORNL). Each tank was dissected as shown in Figs. B.1–B.3 and thoroughly examined for degradation of components and assembly processes.

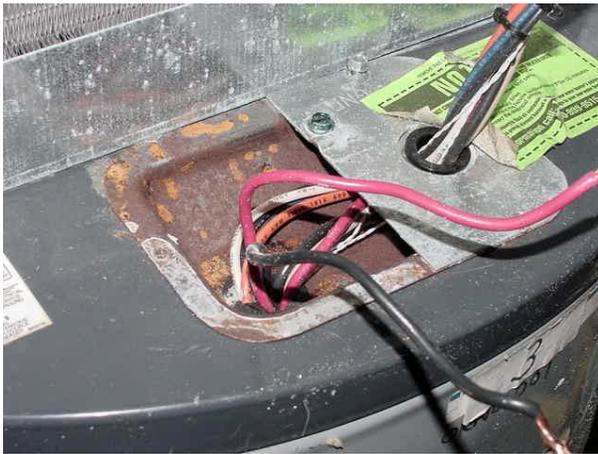
Fig. B.4

Figures B.4 and B.5 illustrate evidence of moisture (rust) inside J—boxes in front of evaporator, and on the upper thermal cut out switch bracket. This is possibly due to leaking plumbing connections, inadequate condensate drainage, or a combination of the two.

Note: Condensate drain issues have been addressed and resolved. A larger drain stub, and an overflow drain, which channels condensate outside of the unit, is incorporated in the current design.

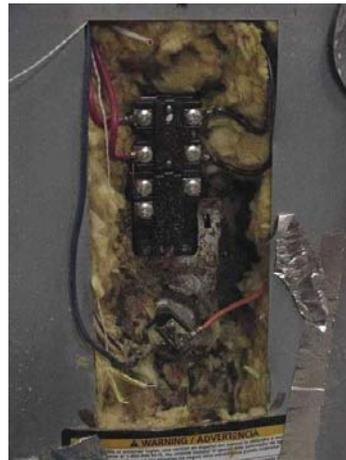
Fig. B.5

Condenser/Top and Bottom Condenser Brazes: Condenser coil tight to outer tank wall. No evidence of movement, shifting or kinking. Brazes in tact.

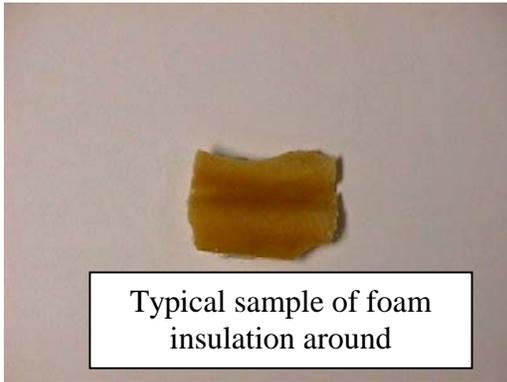
Fig. B.8

Foam Insulation: No evidence of degradation. However, some discoloration was observed on foam insulation that was in direct contact with the top of the condenser coil. See Figs. B.8 and B.9. Noted small pockets where foam insulation was not present under the compressor and evaporator.

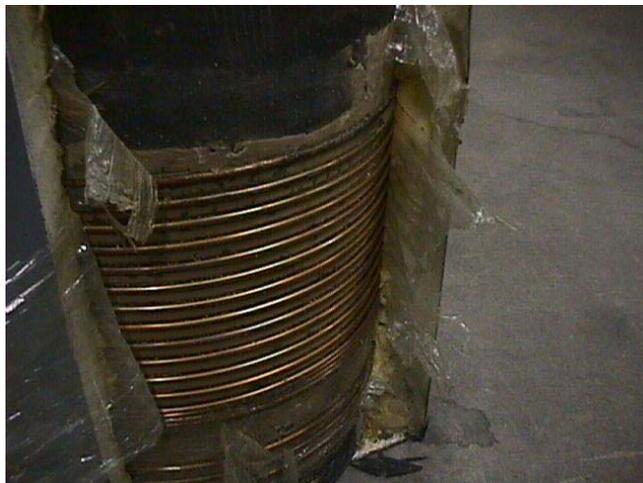
Fig. B.10

Plastic Shrink Wrap: Intact—slightly brittle. Prevented the foam insulation from entering area between condenser coil and tank wall.

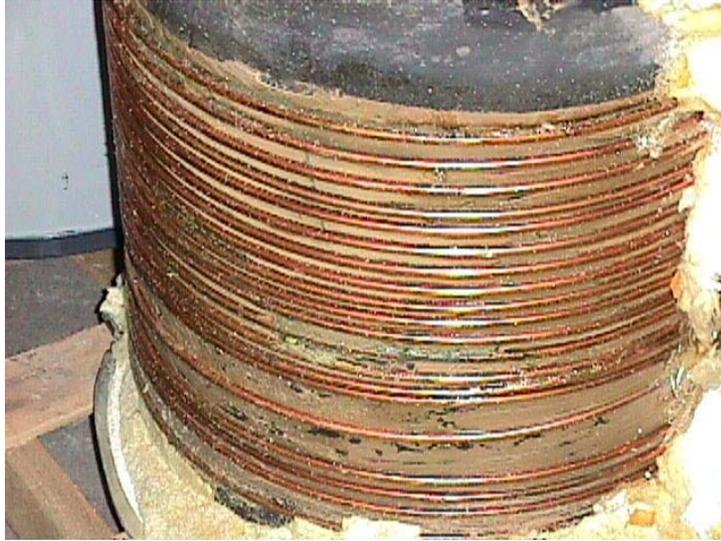
Fig. B.11

Heat Transfer Compound: Slightly discolored, remained in place and solidified to a wax-like texture.

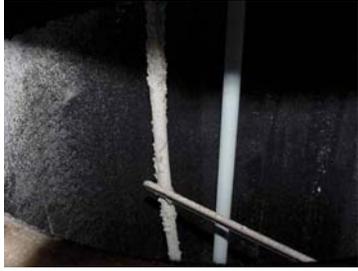
Fig. B.16

Anode Rods: Figure B.16 depicts the anode on units 3 and 4 that were partially dissolved, but still intact. Figure B.17 illustrates the condition of the anodes on units 2,7,9, and 10 - mostly dissolved, and split along the vertical axis. The anode on units 5 and 8 was completely dissolved, with only the steel core remaining (see Fig. B.18).
